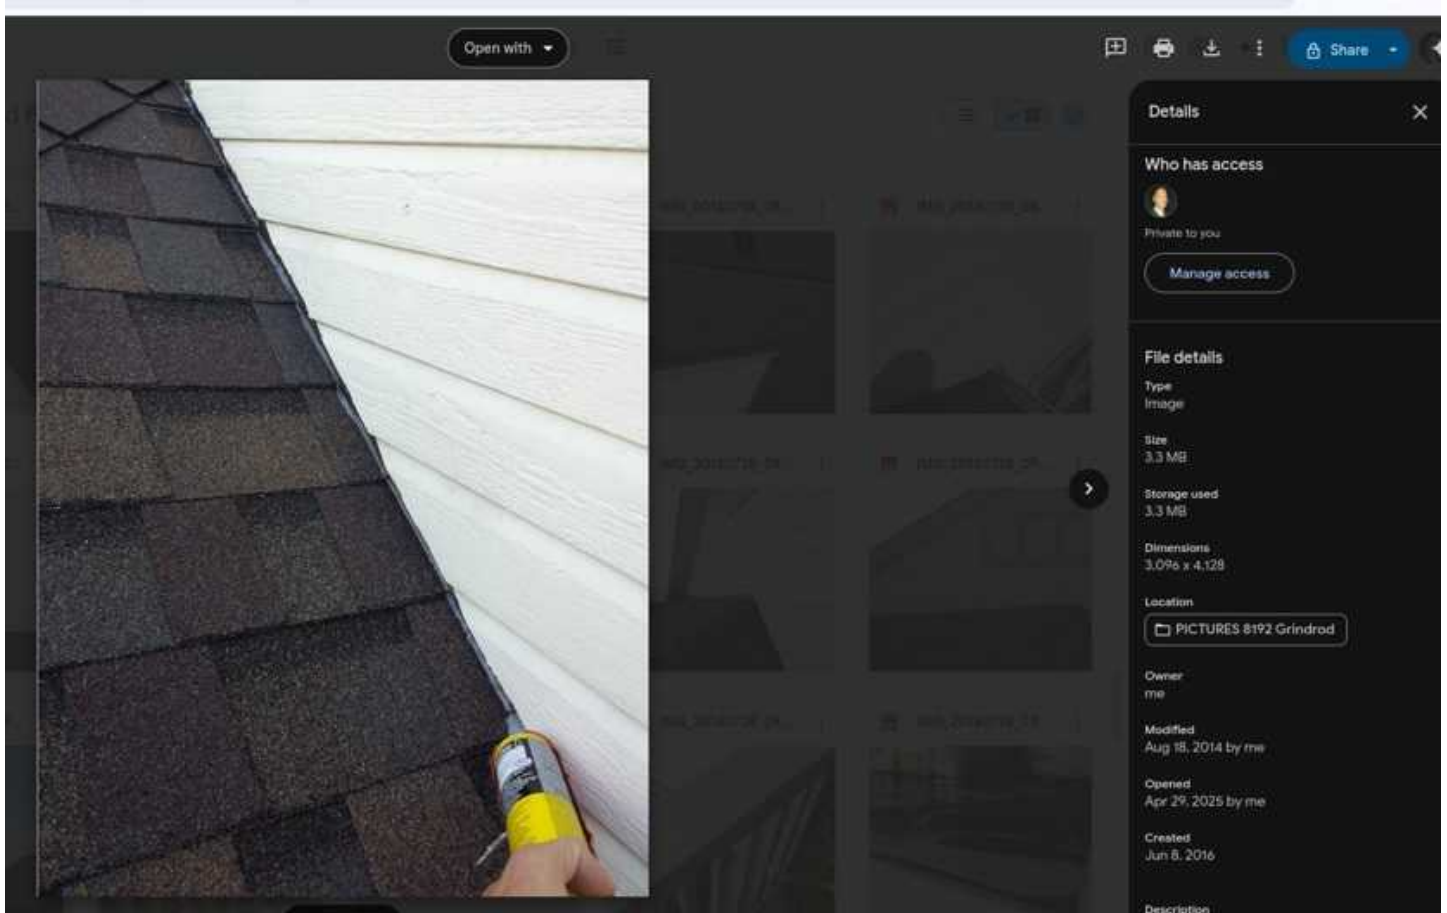
1      2-2014 caulking existed

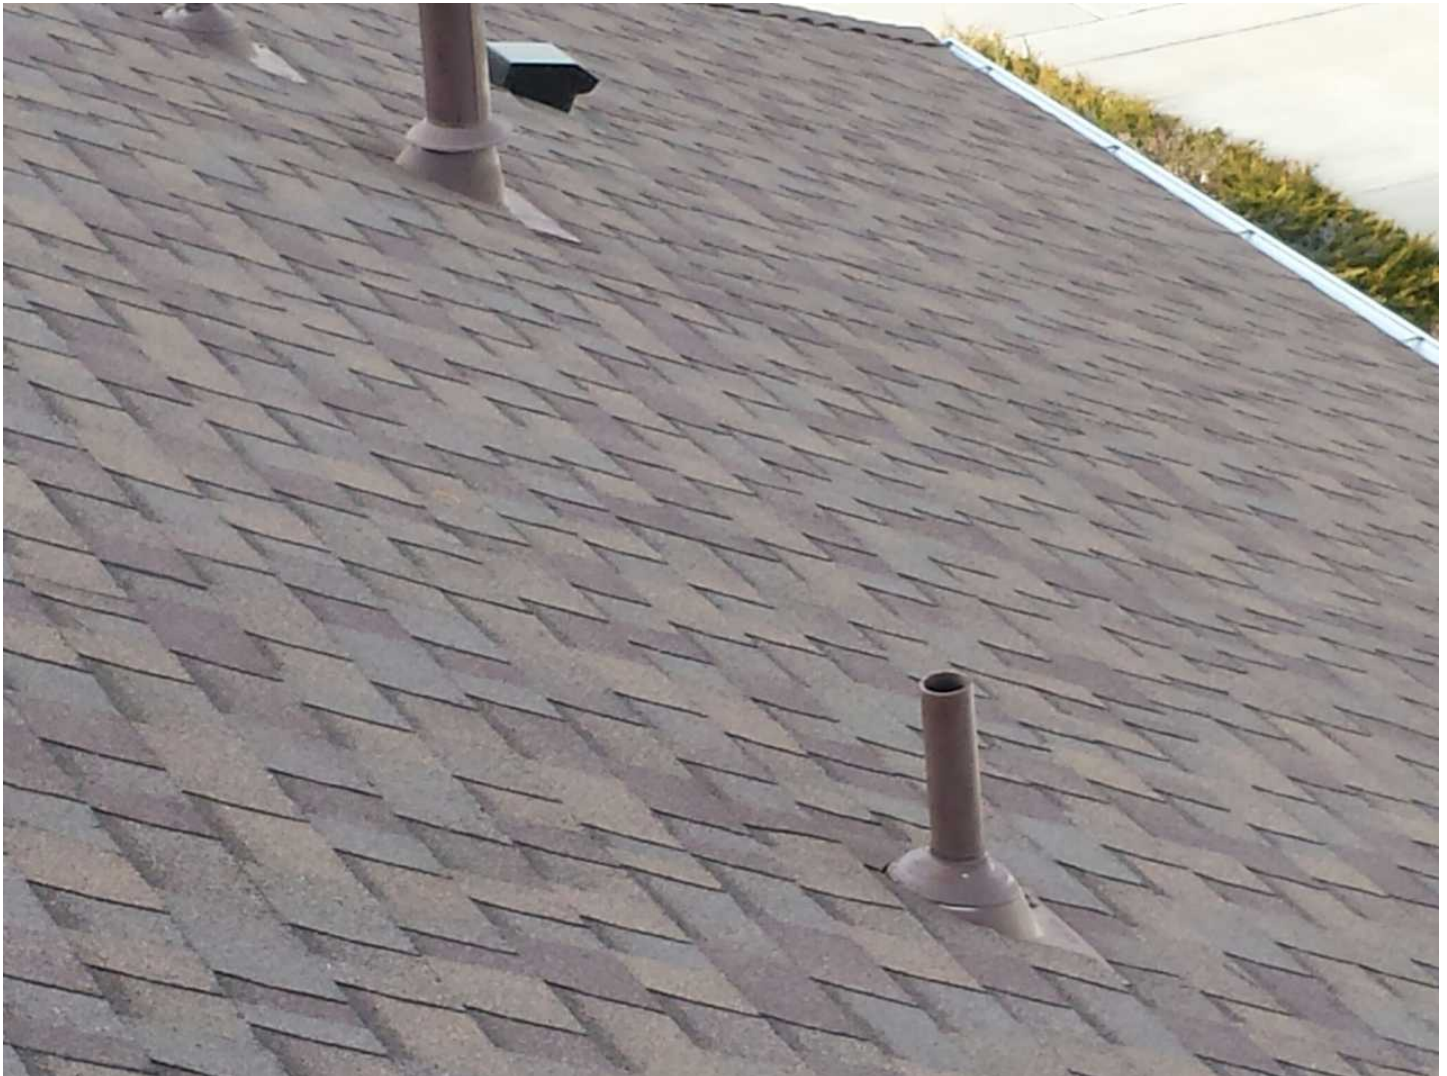
2 3-2014 metal pipe jacks

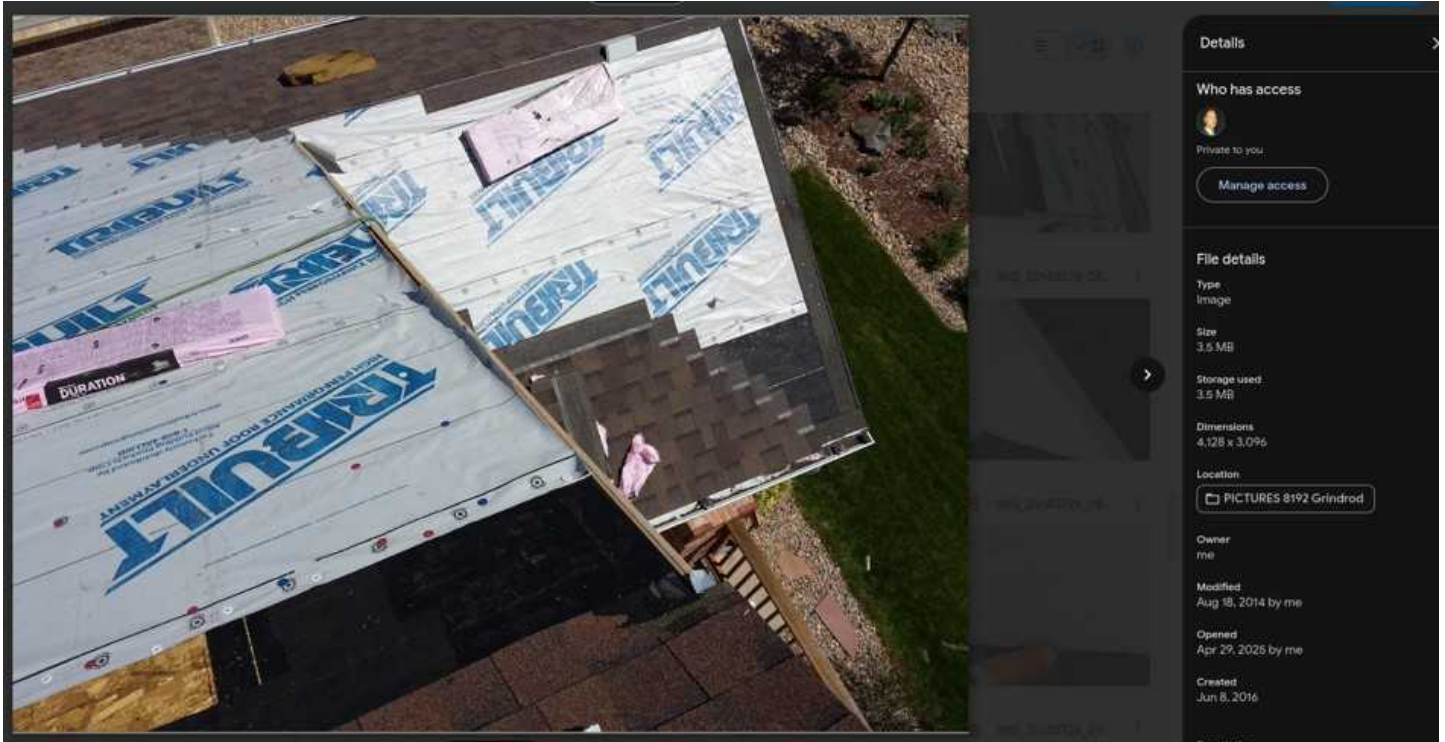
- 4      5-2014 very good duration shingle existed

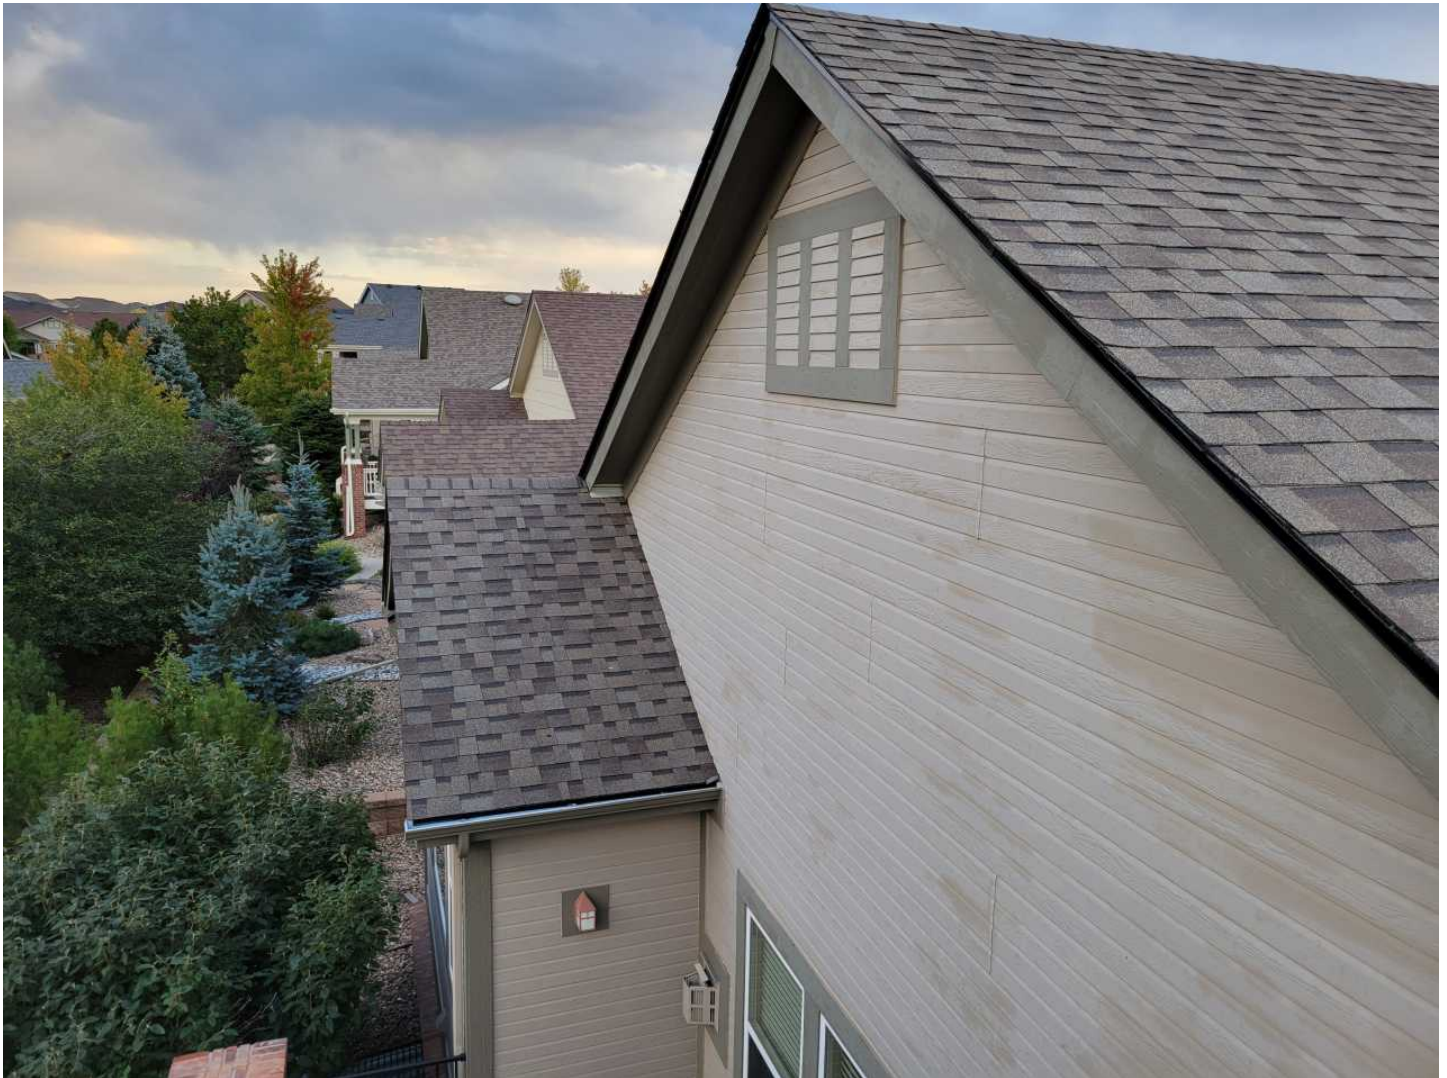
5

6-bird block soffit flashing

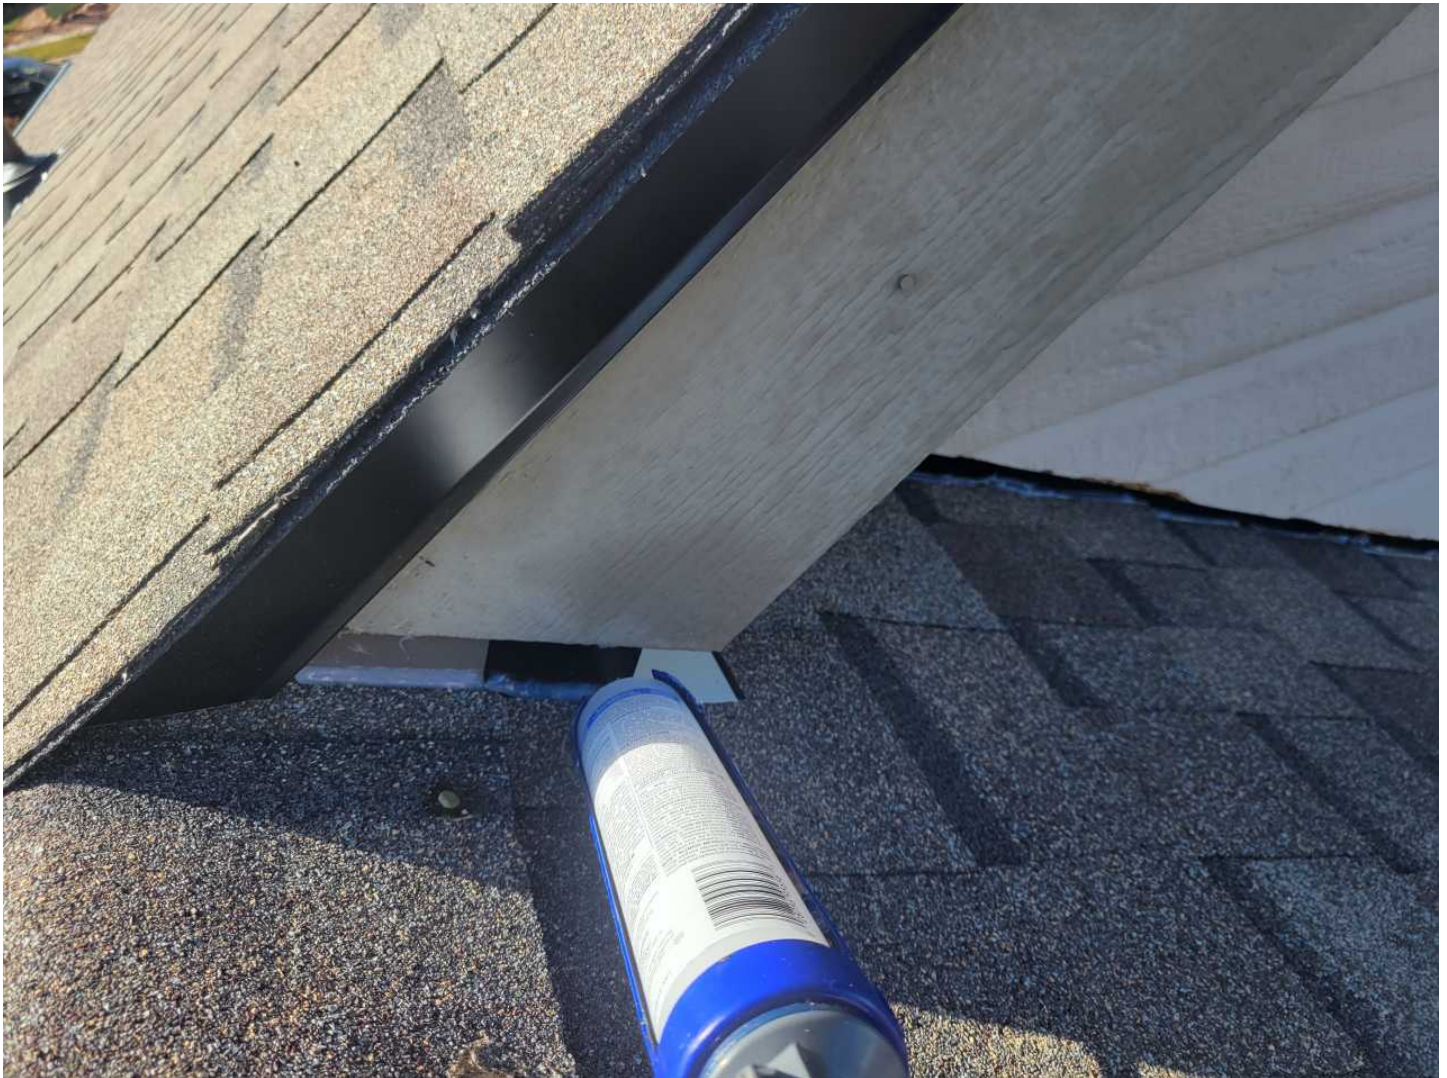
6 7-caulking as existed

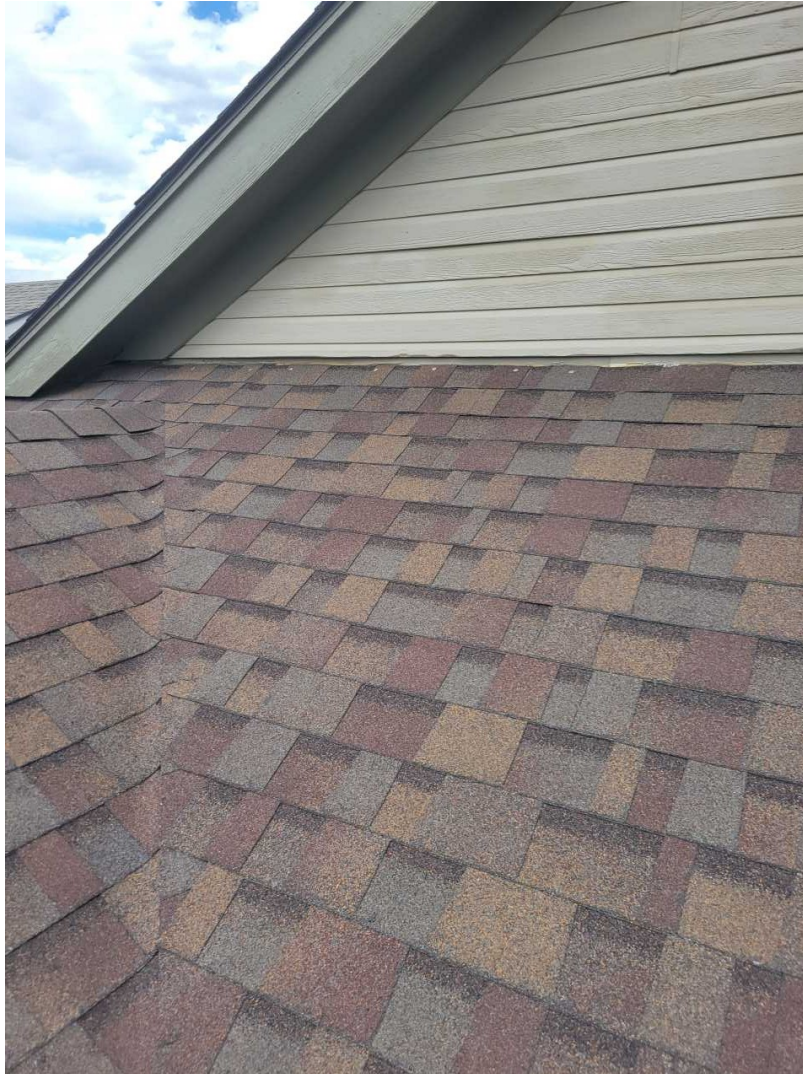
7

8-color starter as existed on  
headwall nailed o

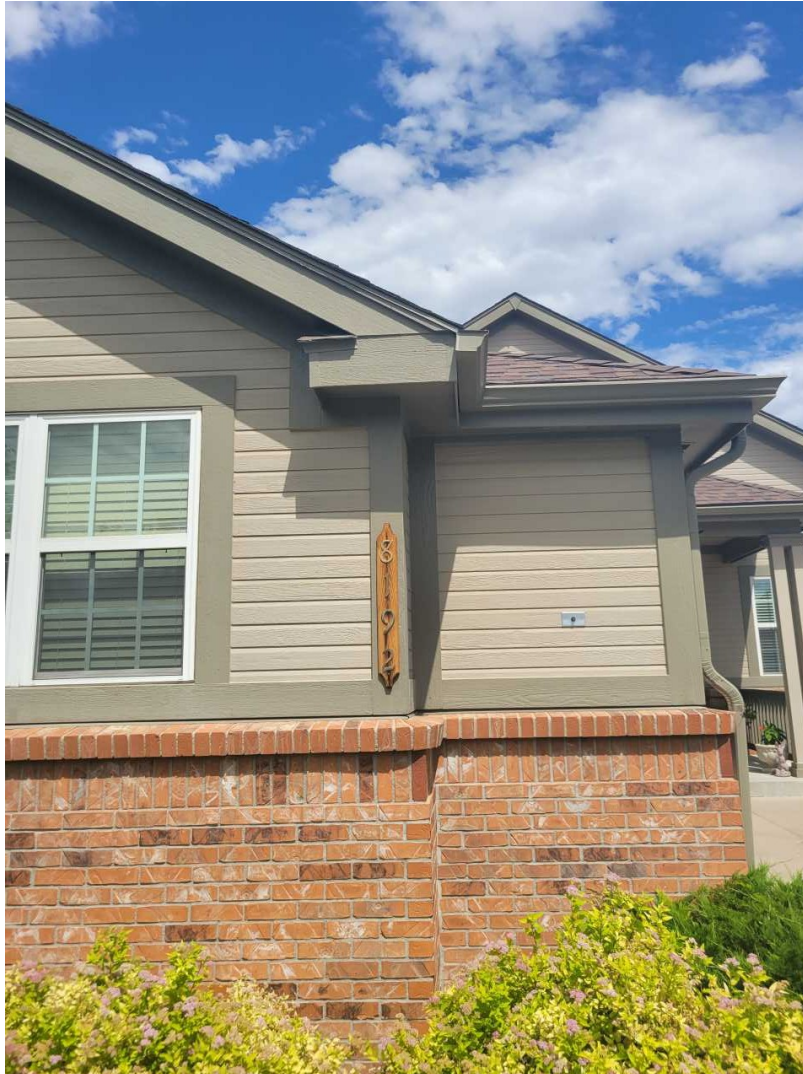
9

10-gable cornice return

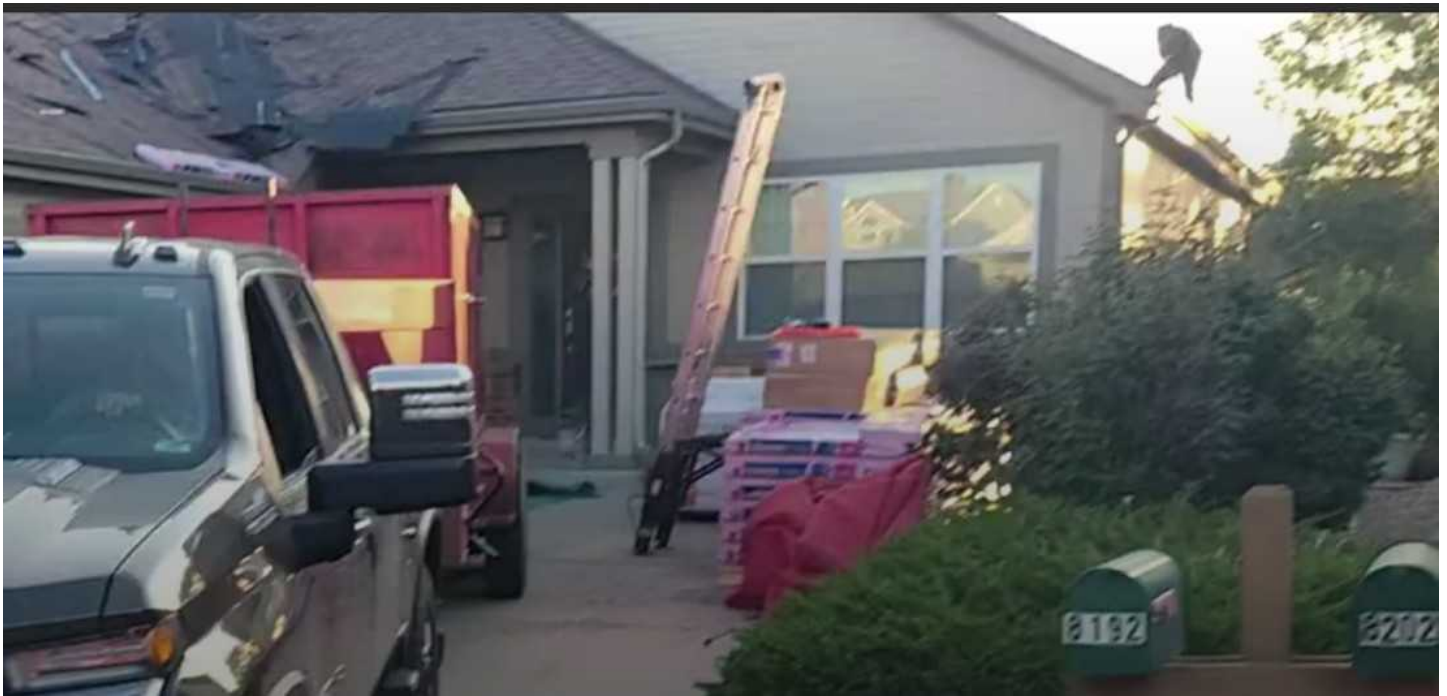
- 10      11-hand stock and special delivery  
shingles

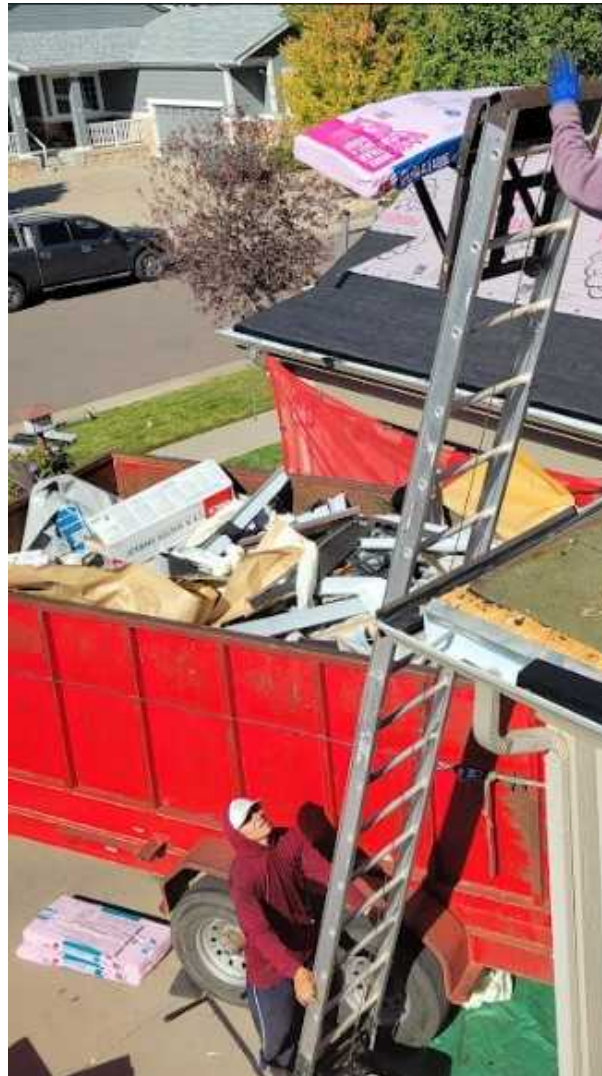
- 11      12-hand stock shingle to prevent  
driveway damage

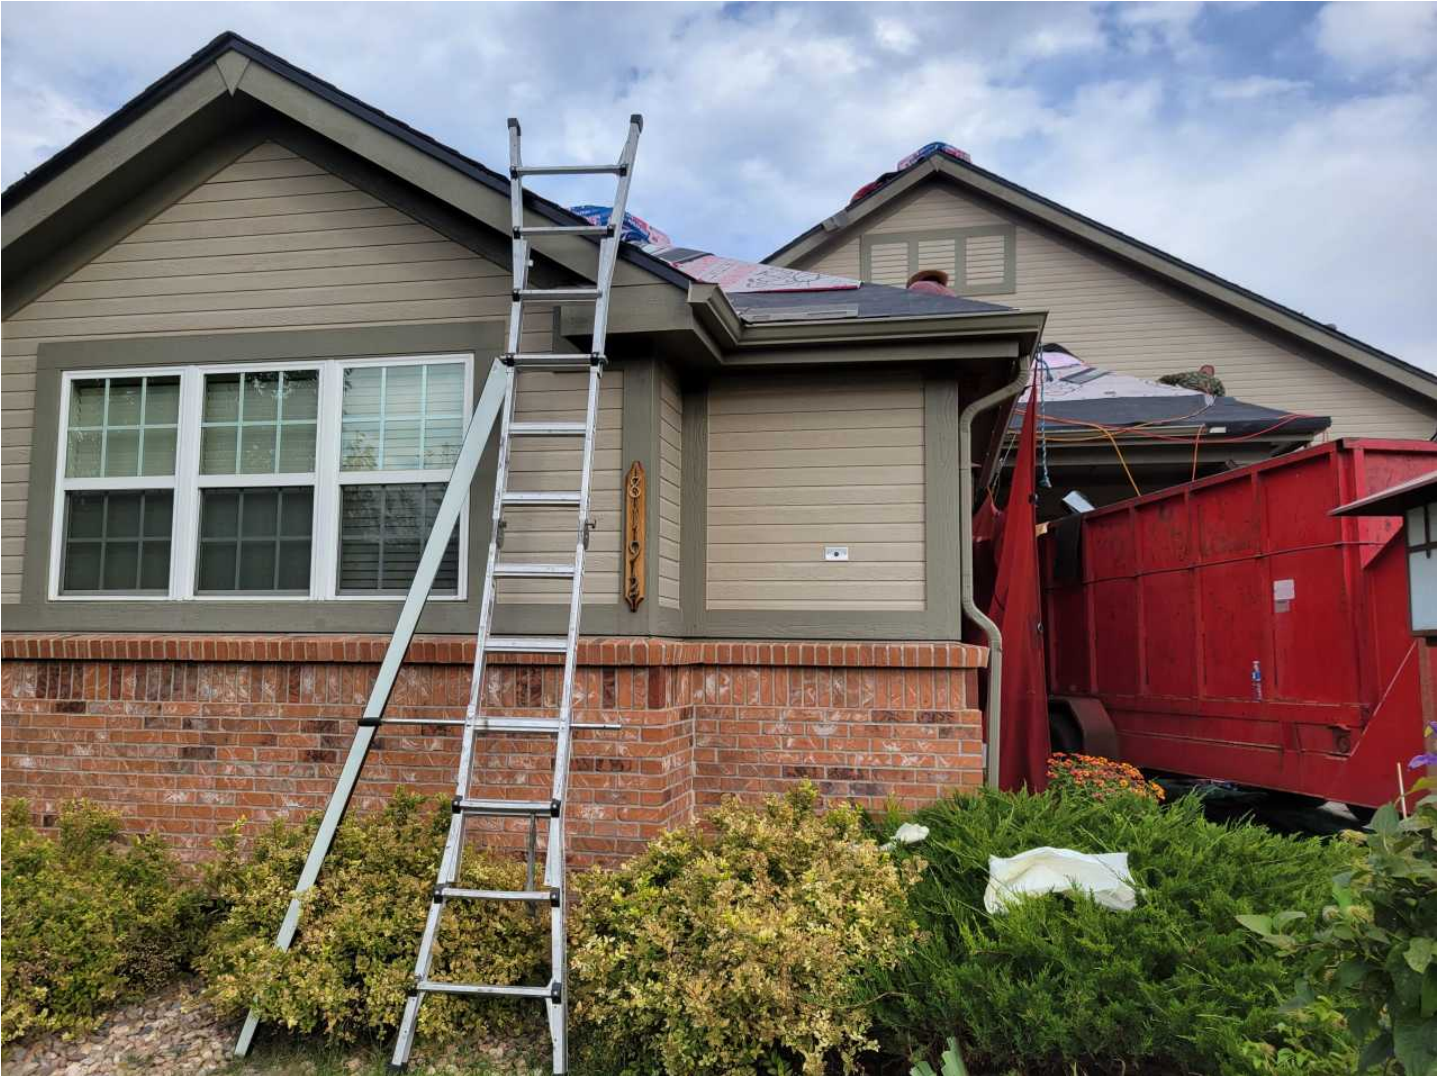
12      13-haul away with light weight  
rubber tire contr      Date Taken: 10/8/2024

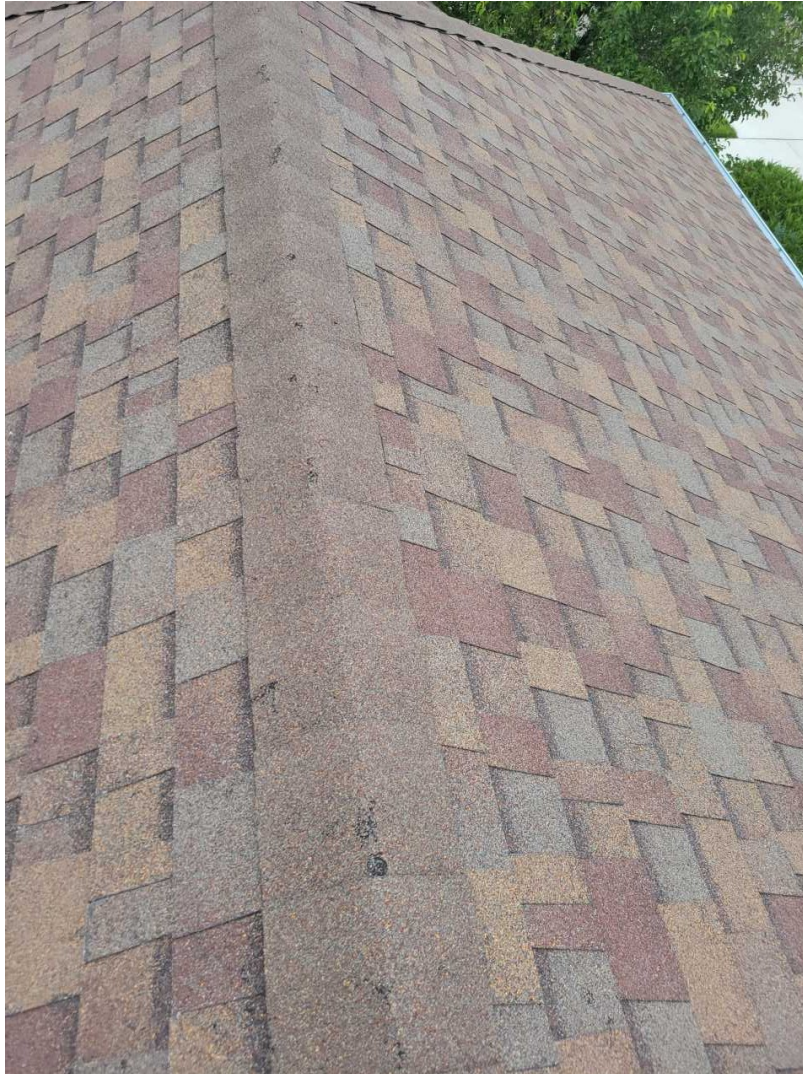
13      14-high profile ridge as existed      Date Taken: 6/24/2024

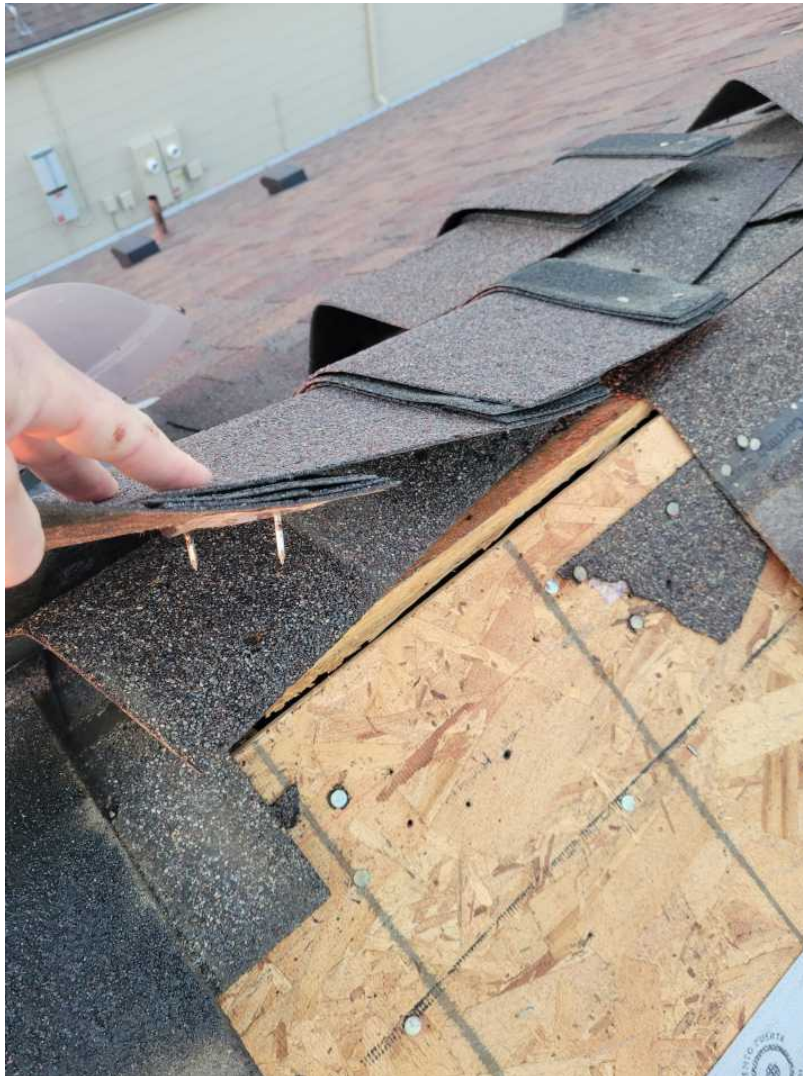
14      15-high profile ridge was existing      Date Taken: 10/8/2024

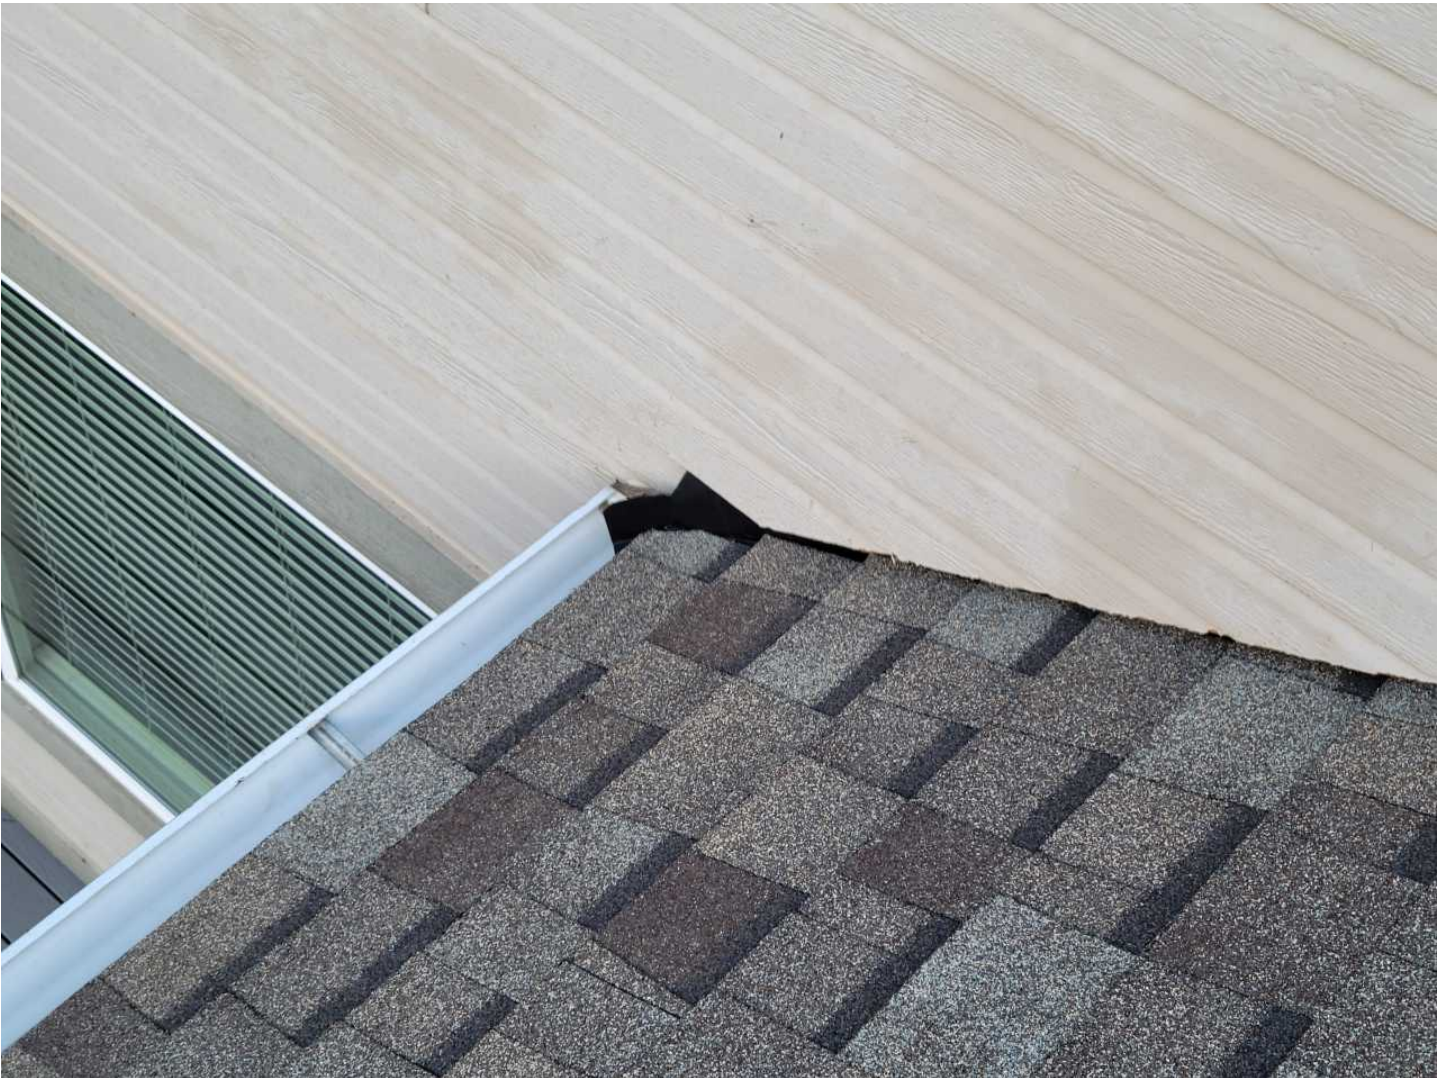
15      16-kickout flashings as existed      Date Taken: 10/8/2024

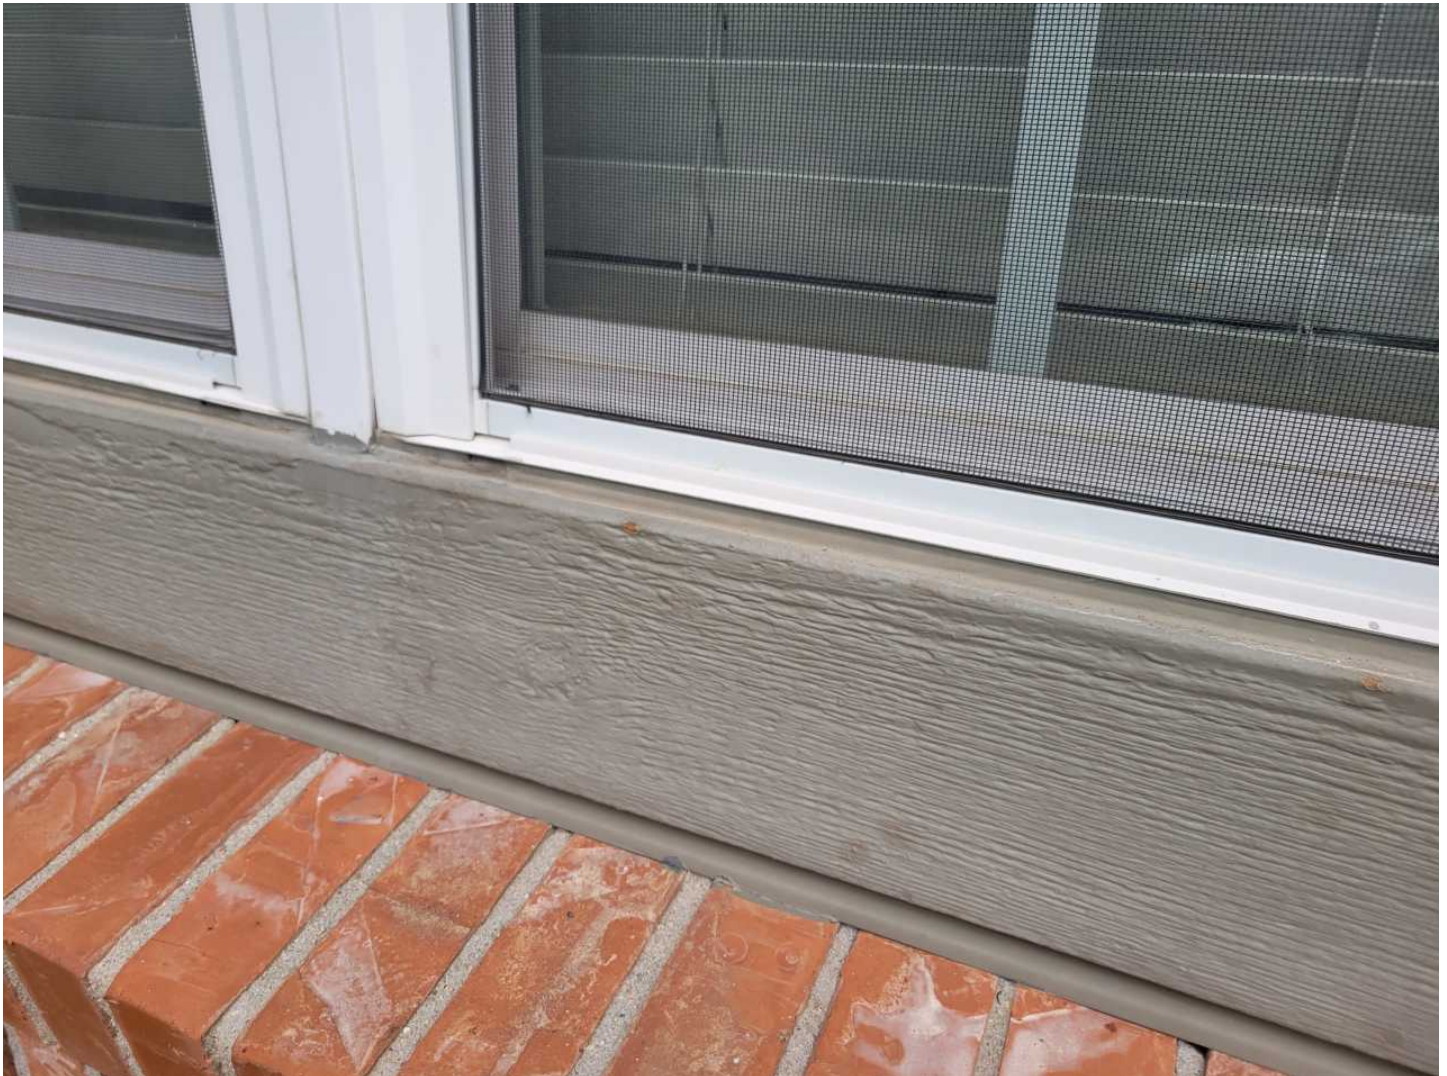
16 17-paint trim front window

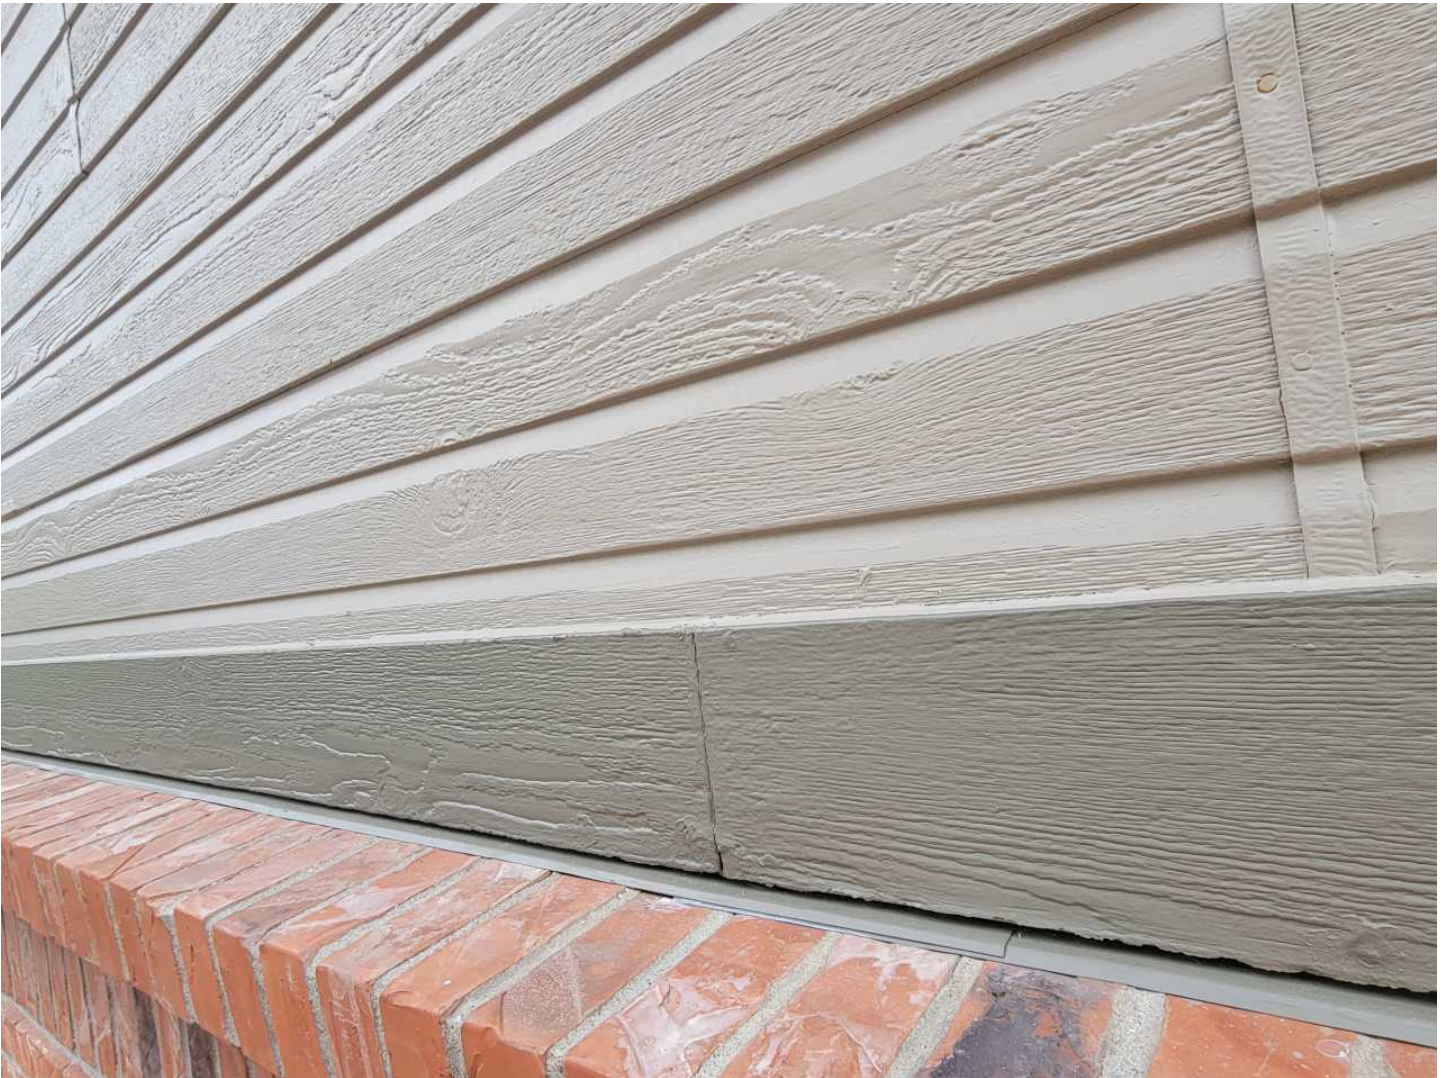
17      18-paint trim left elevation(1)      Date Taken: 6/24/2024

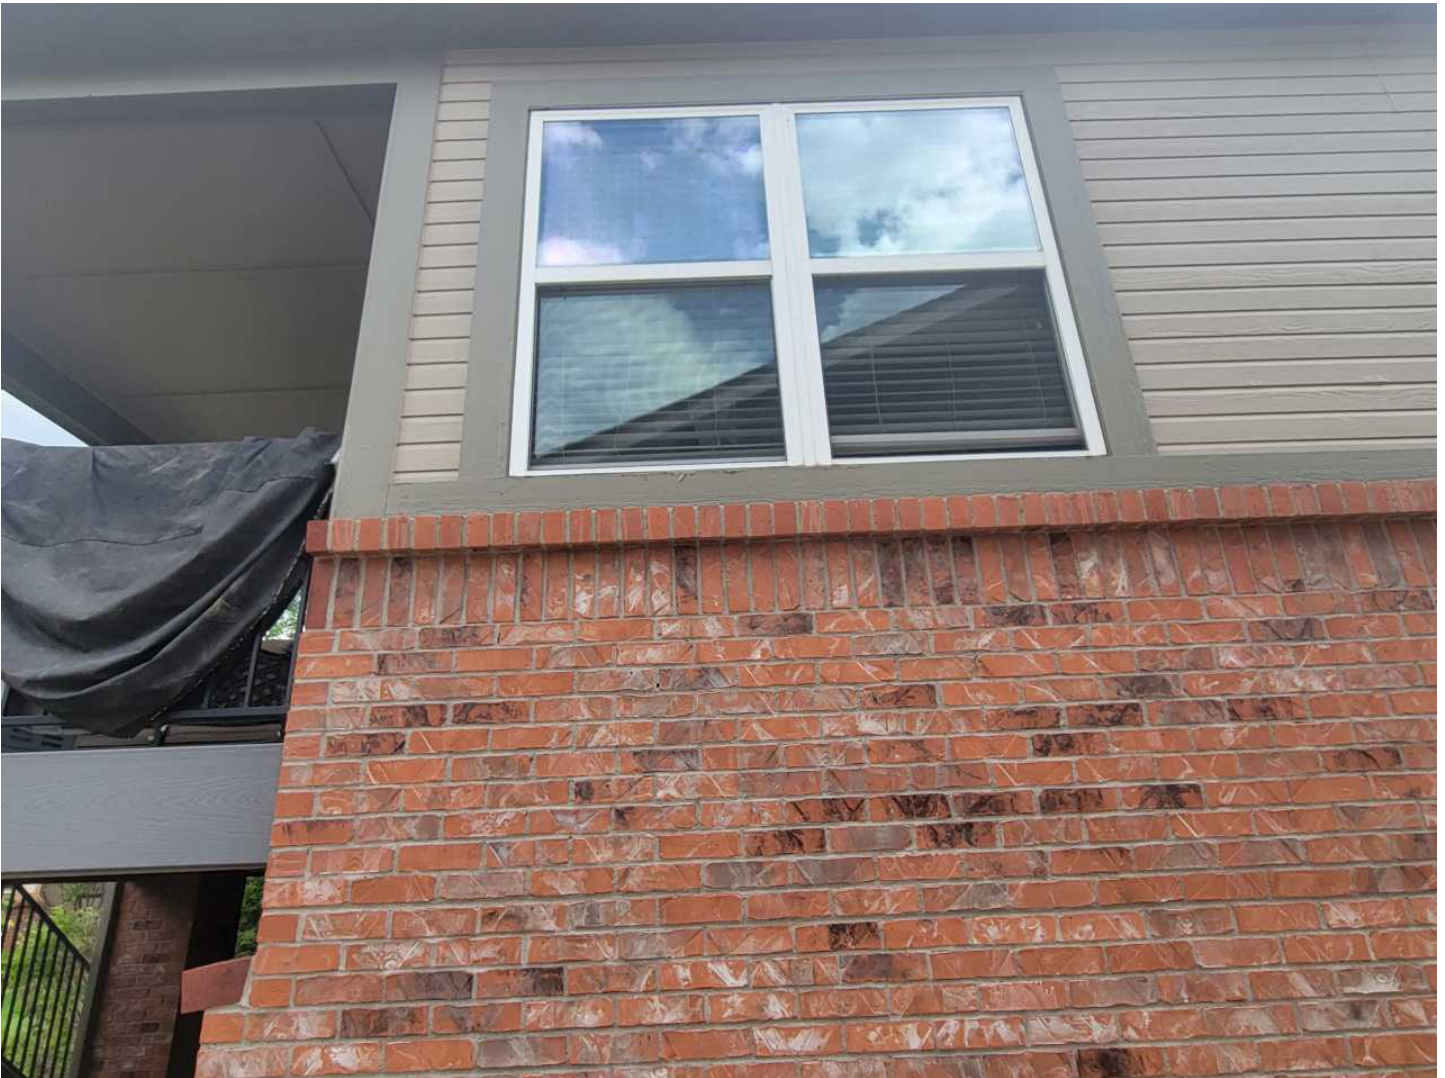
18 19-paint trim left elevation

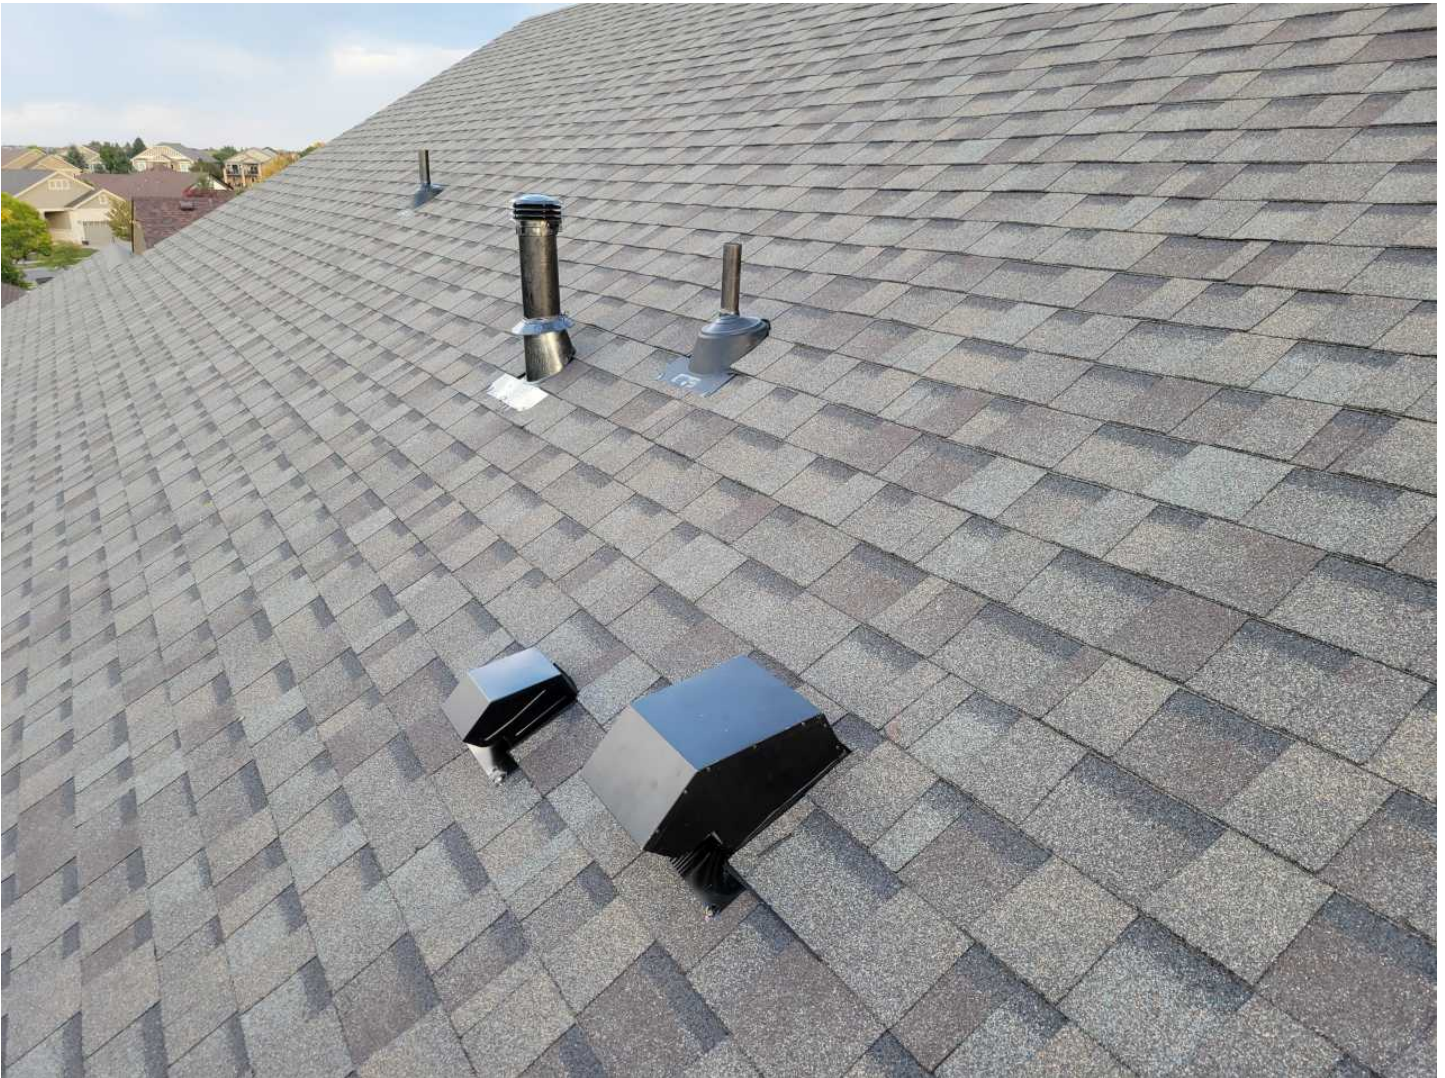
19 20-primed painted vents caps  
collars

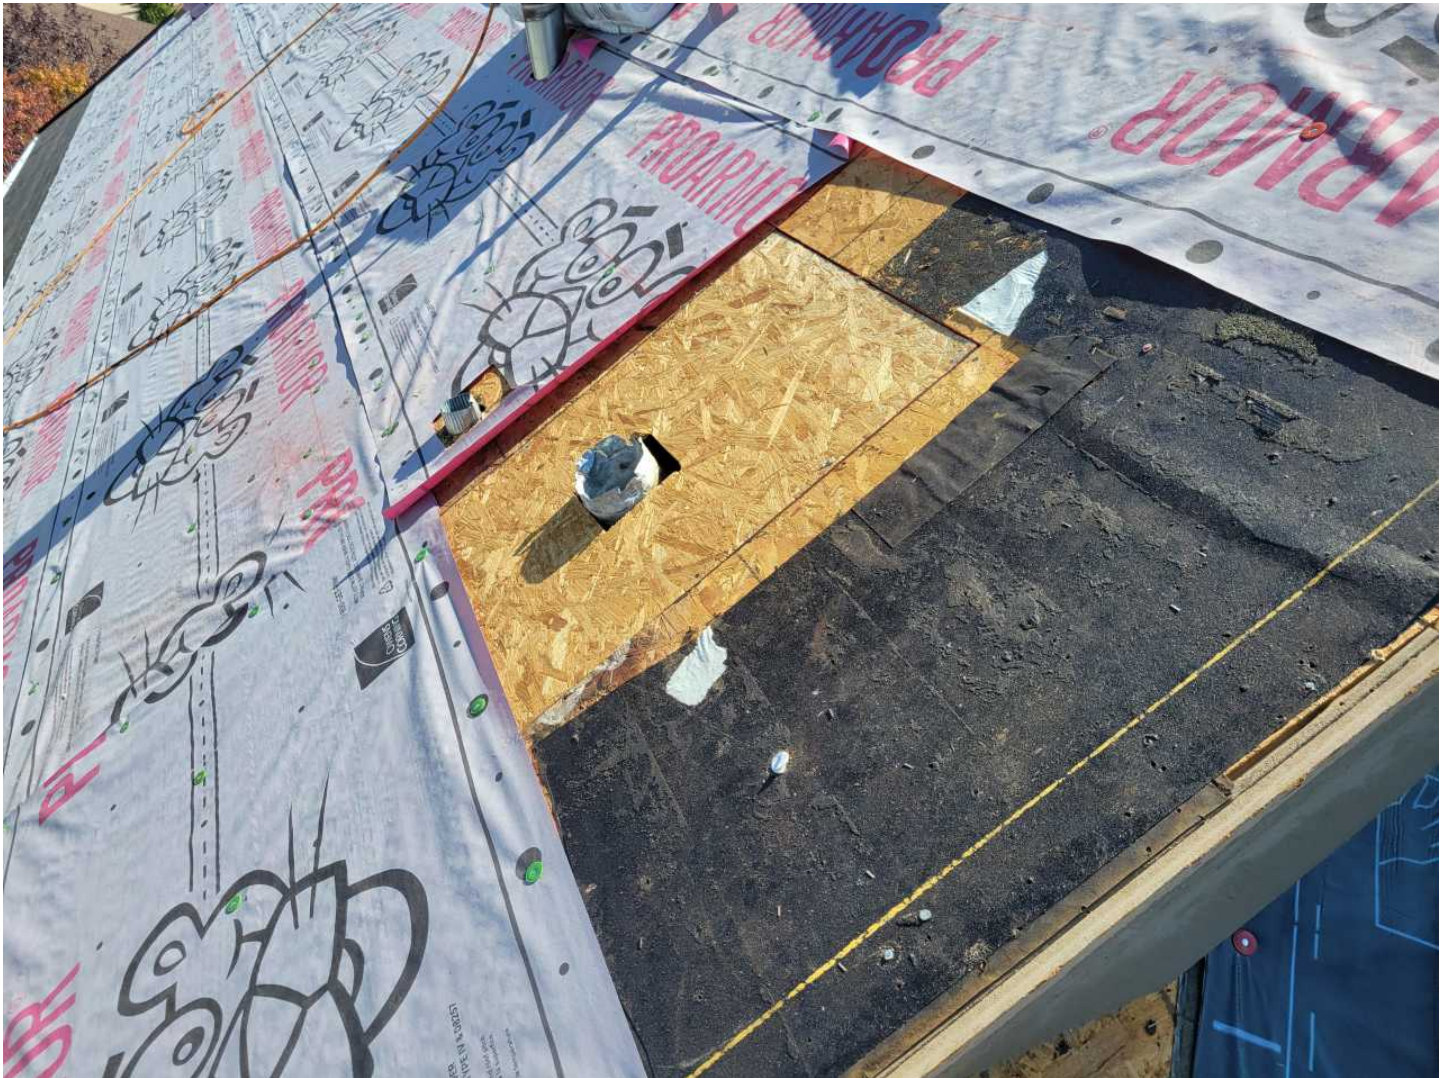
20

21-rake ice water as existed
