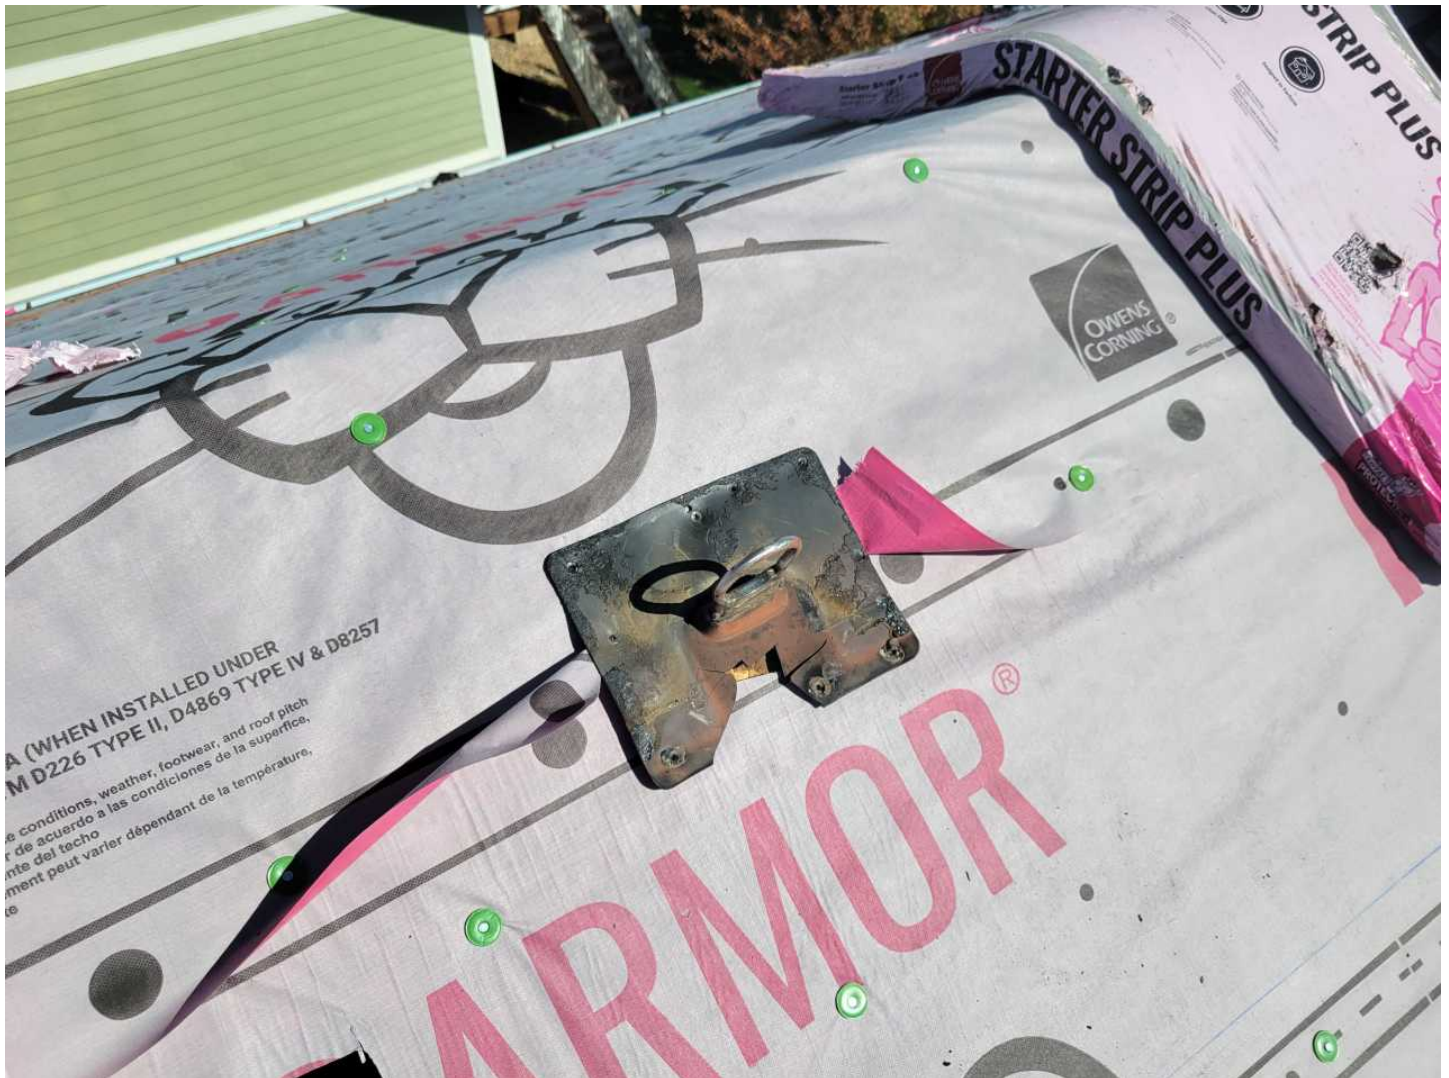
21 22-reuse reseal anchors

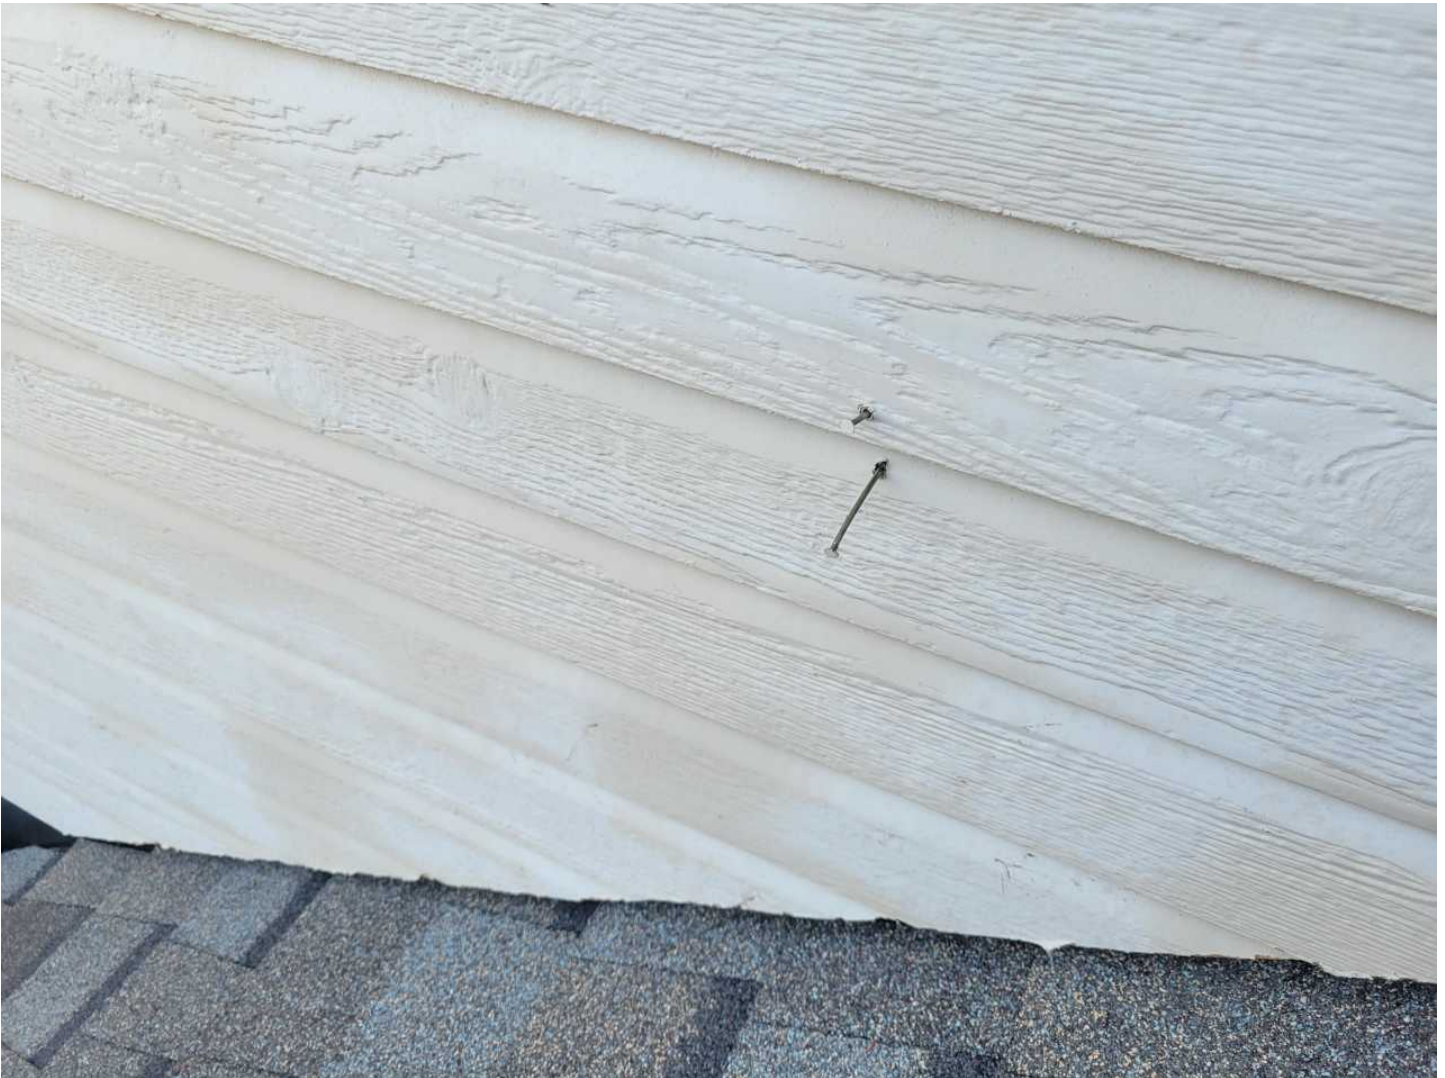
22      23-roofer hours to renail siding      Date Taken: 10/25/2024

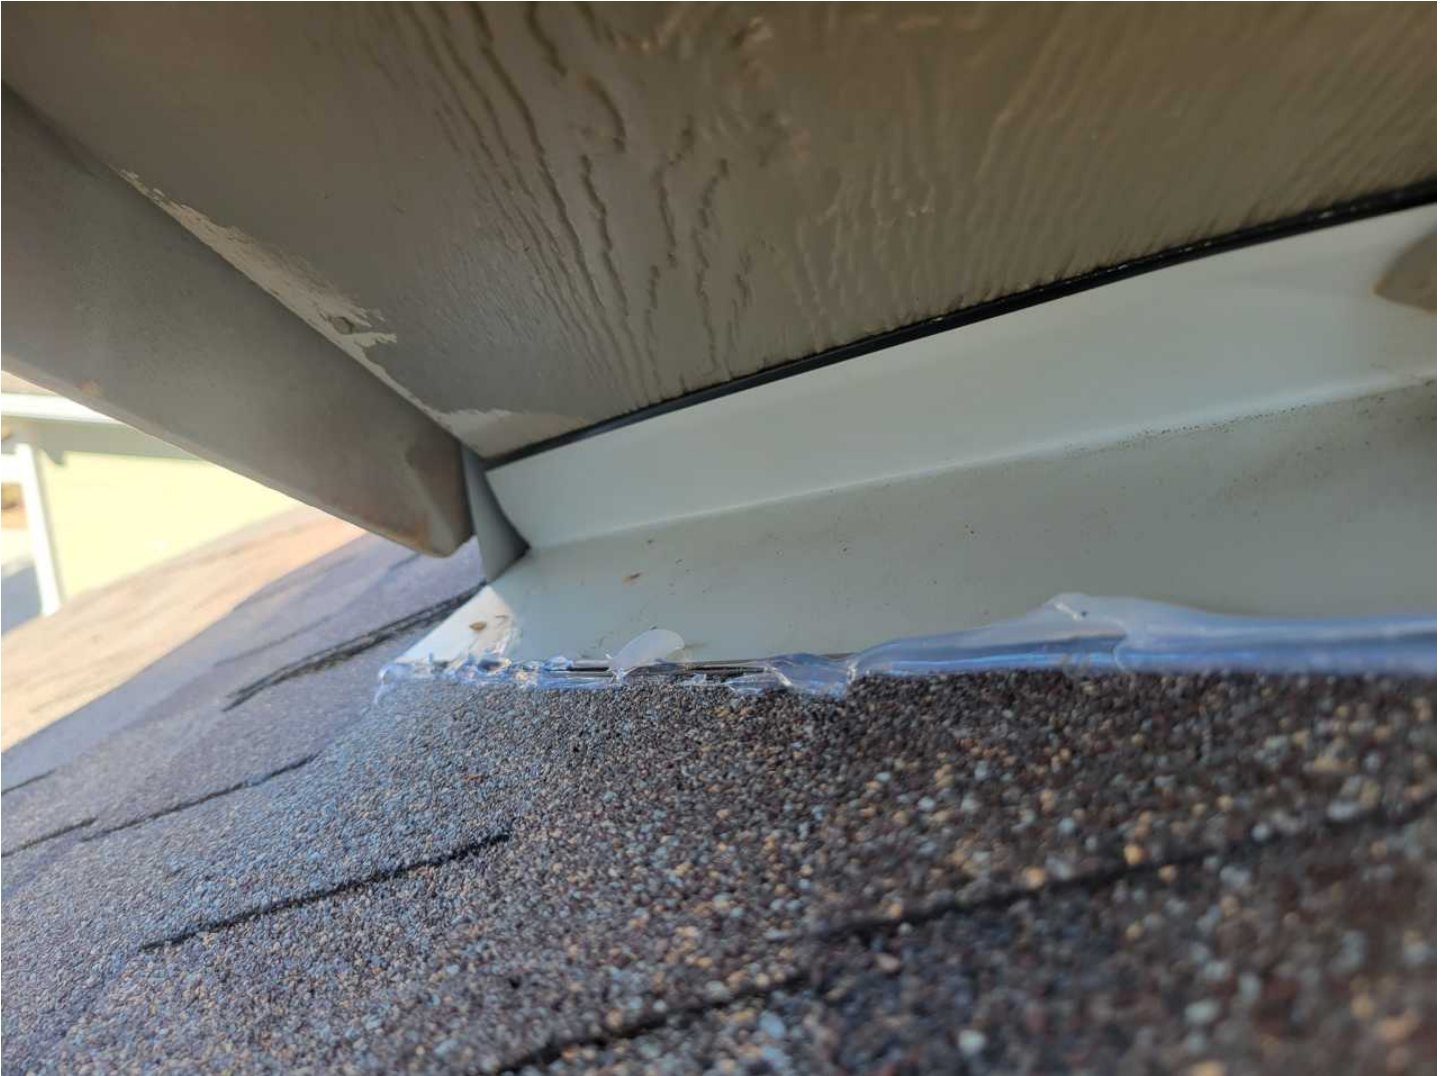
23 24-silicone and flashing under  
soffite vent as e

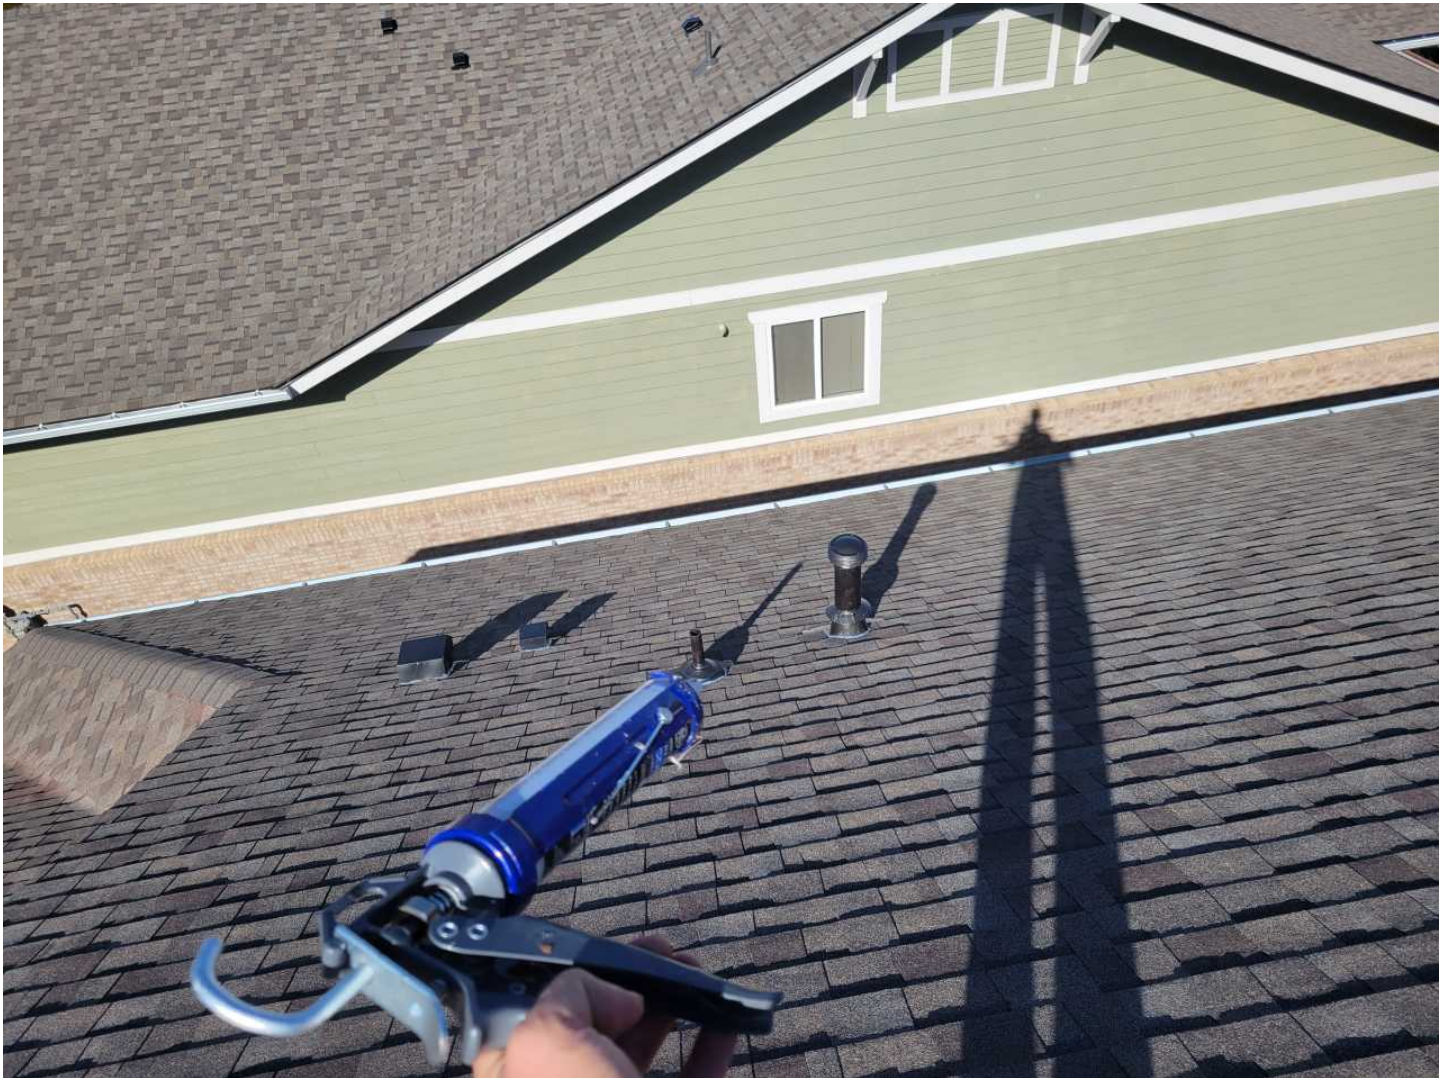
24      25-silicone pipe jacks as existed      Date Taken: 10/25/2024

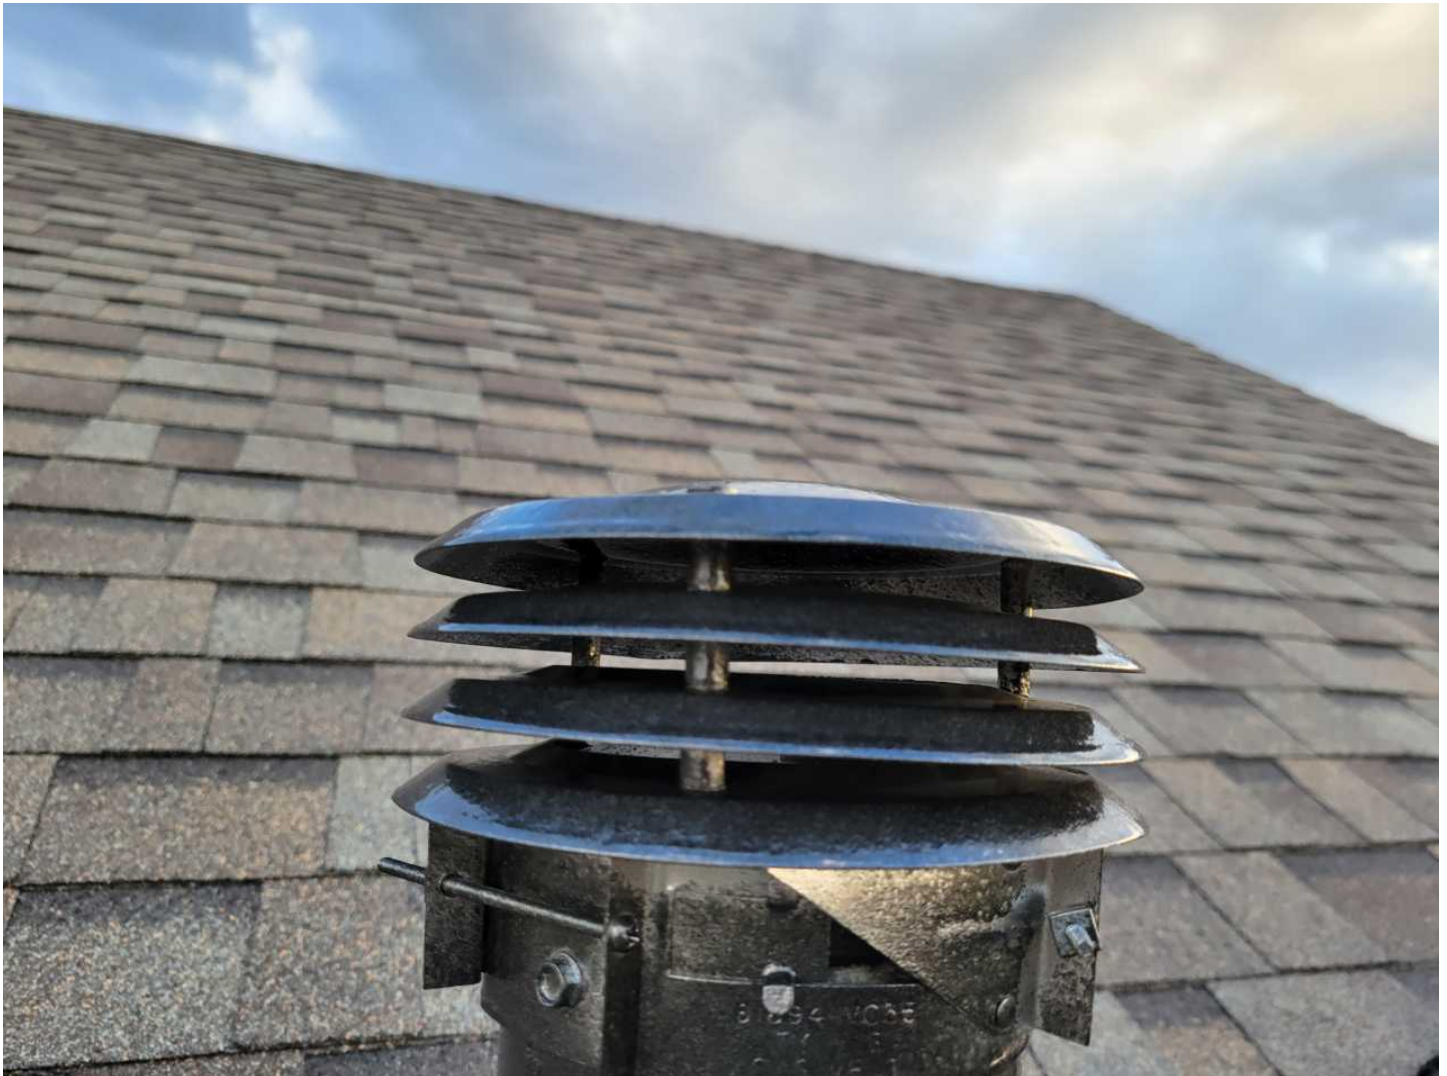
25      26-site supervisor verify vent  
install or HVAC m

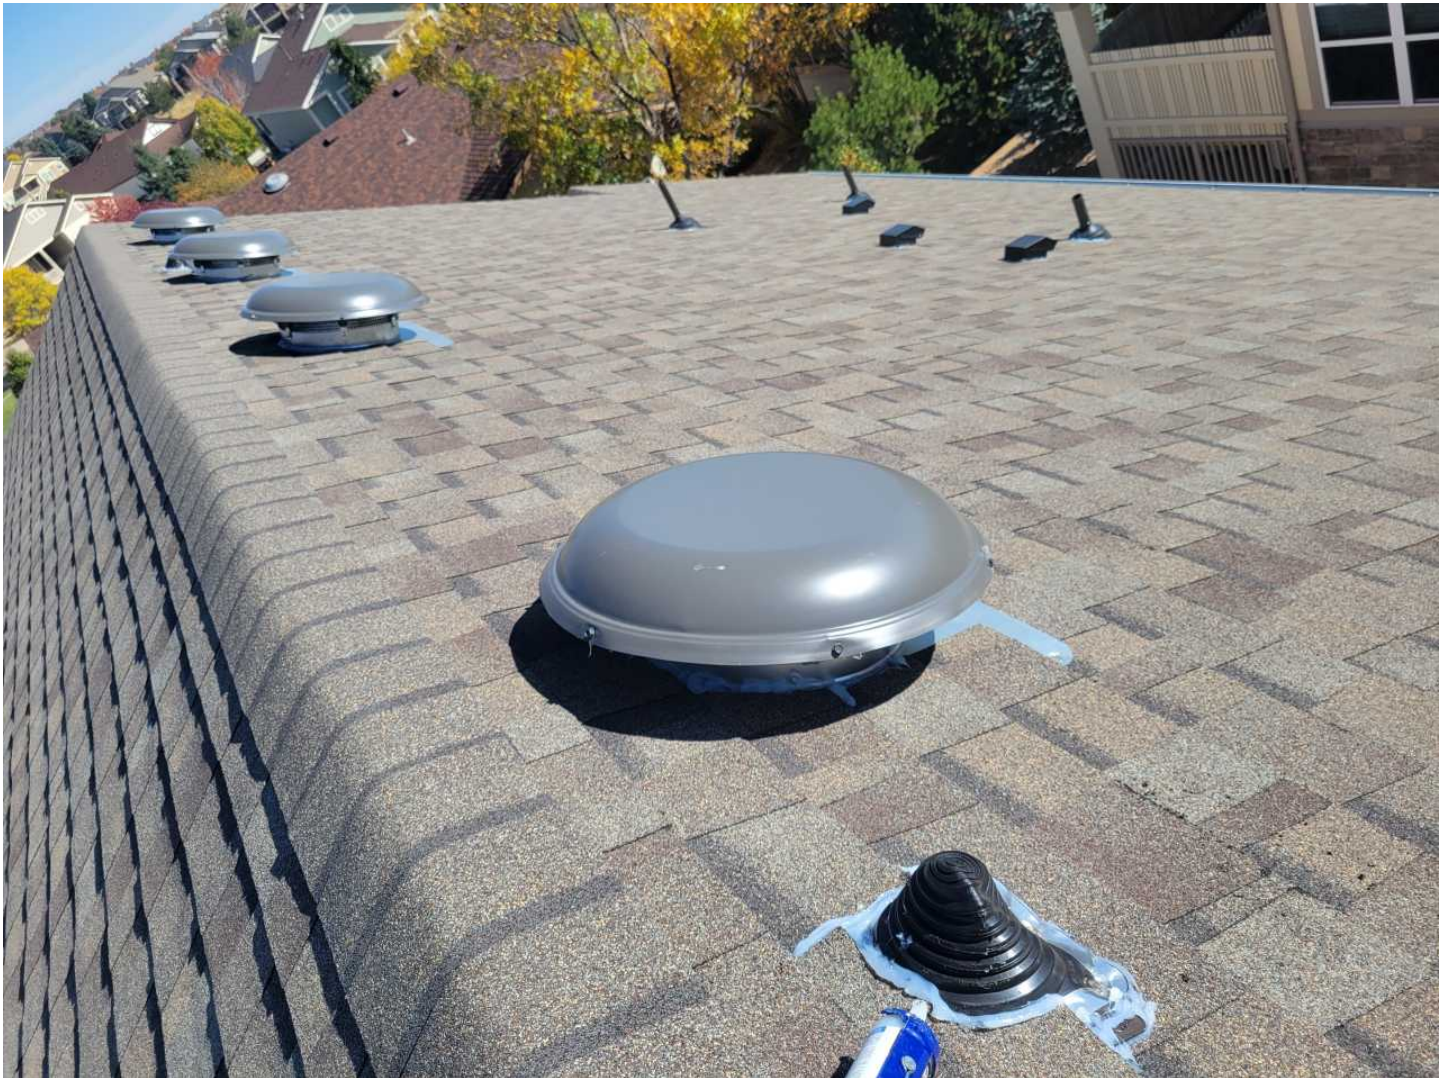
26      27-split boot to seal roof anchors      Date Taken: 10/25/2024

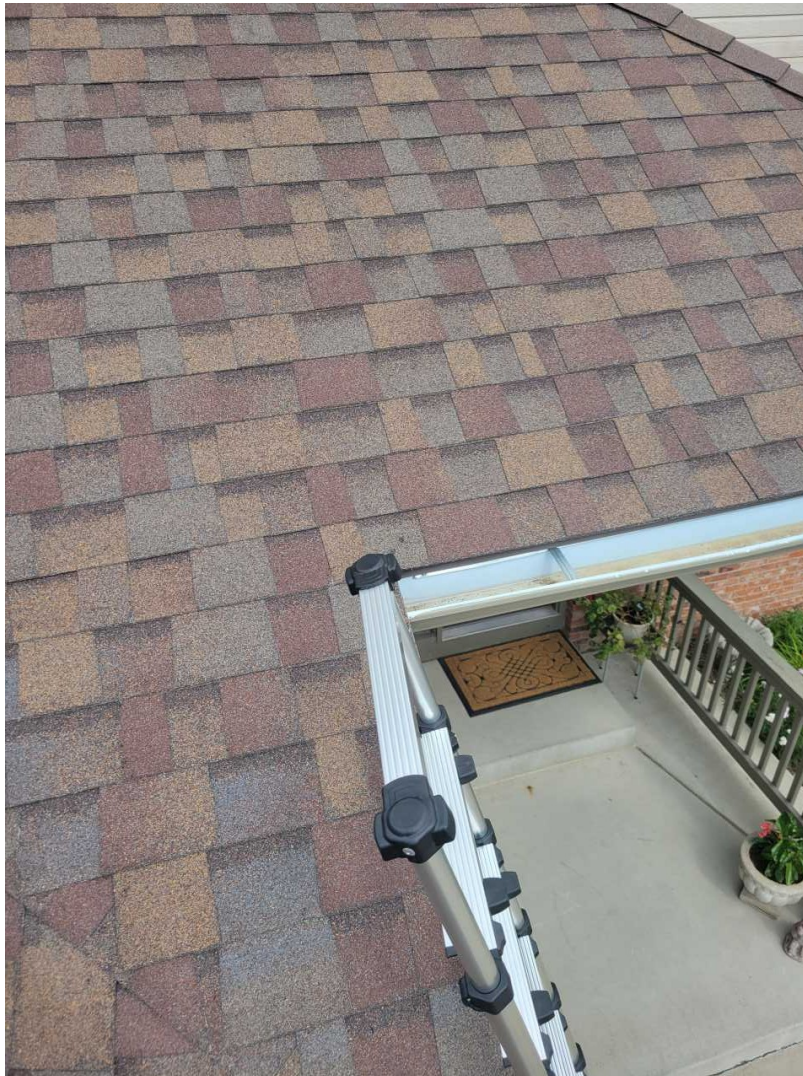
27      28-starter in valley color shingle      Date Taken: 6/24/2024

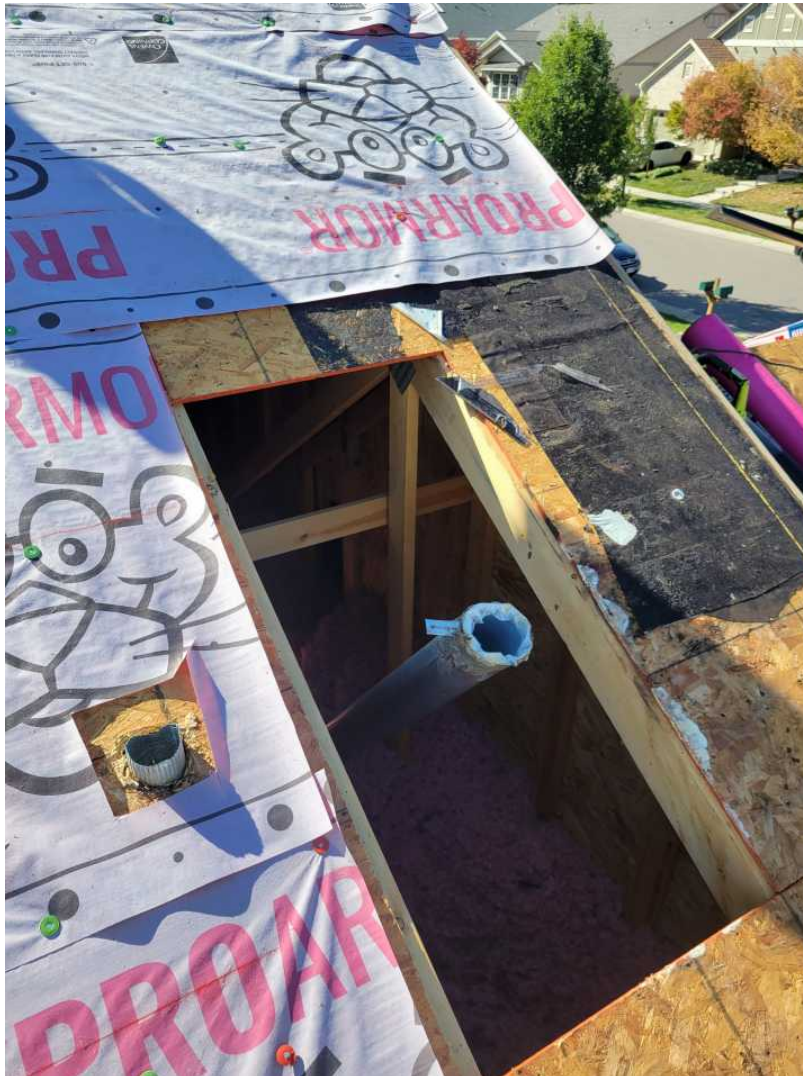
28      1-water soak decking replace      Date Taken: 10/8/2024
